431.

Huss Top Spin main tower mast cracking

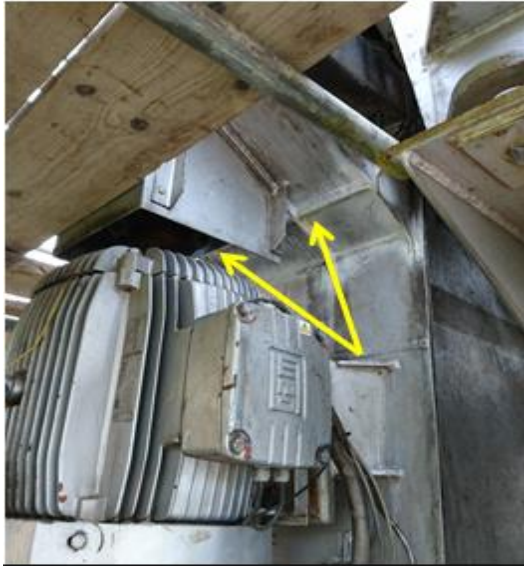
We have received a report from a UK registered inspection body that areas of cracking have been found on the main tower masts of a Huss Top Spin. It is understood the device is 30 years old. The crack propagates across nearly the full width of the tower and is also propagating into welds perpendicular to the main crack. Upon removal and subsequent testing of the drive pinions, several were failed due to cracking within the tooth valley.

Figure 1 Cracking location

The manufacturer has been informed and asked for its recommendations and weld specification procedures.

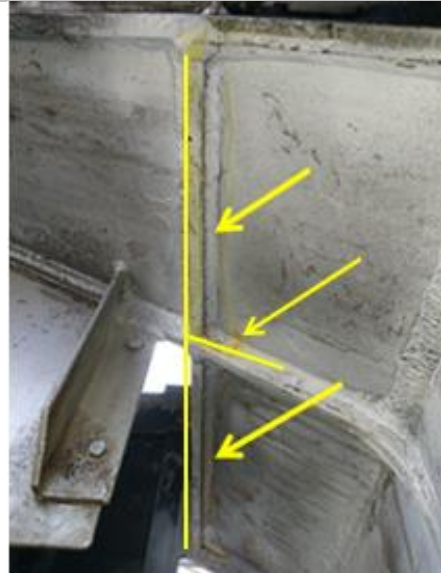
Figure 2 Cracking location

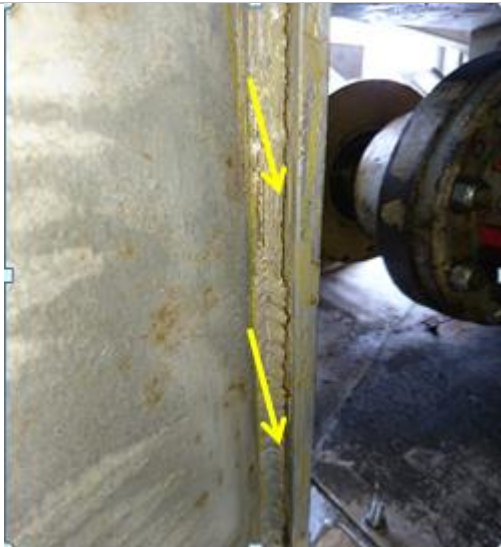
Figure 3: Cracking

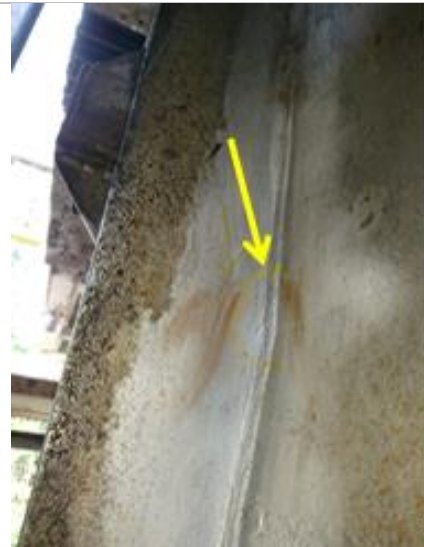
Figure 4: Weld cracking perpendicular to the main crack

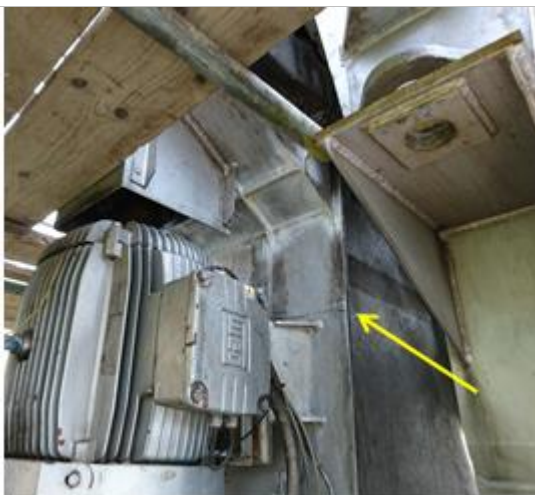
Figure 5: Location of weld cracking perpendicular to the main crack

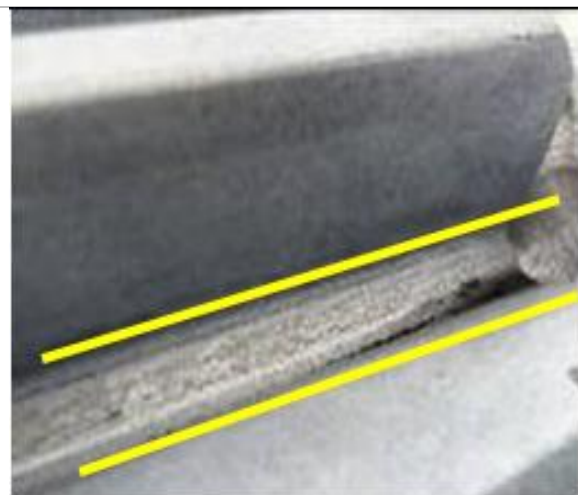
Figure 6: Pinion cracking
